# THE CHAMPLAIN TOWERS COLLAPSE

Professional & Legal Implications for Design Firms

# The Champlain Towers South Partial Collapse

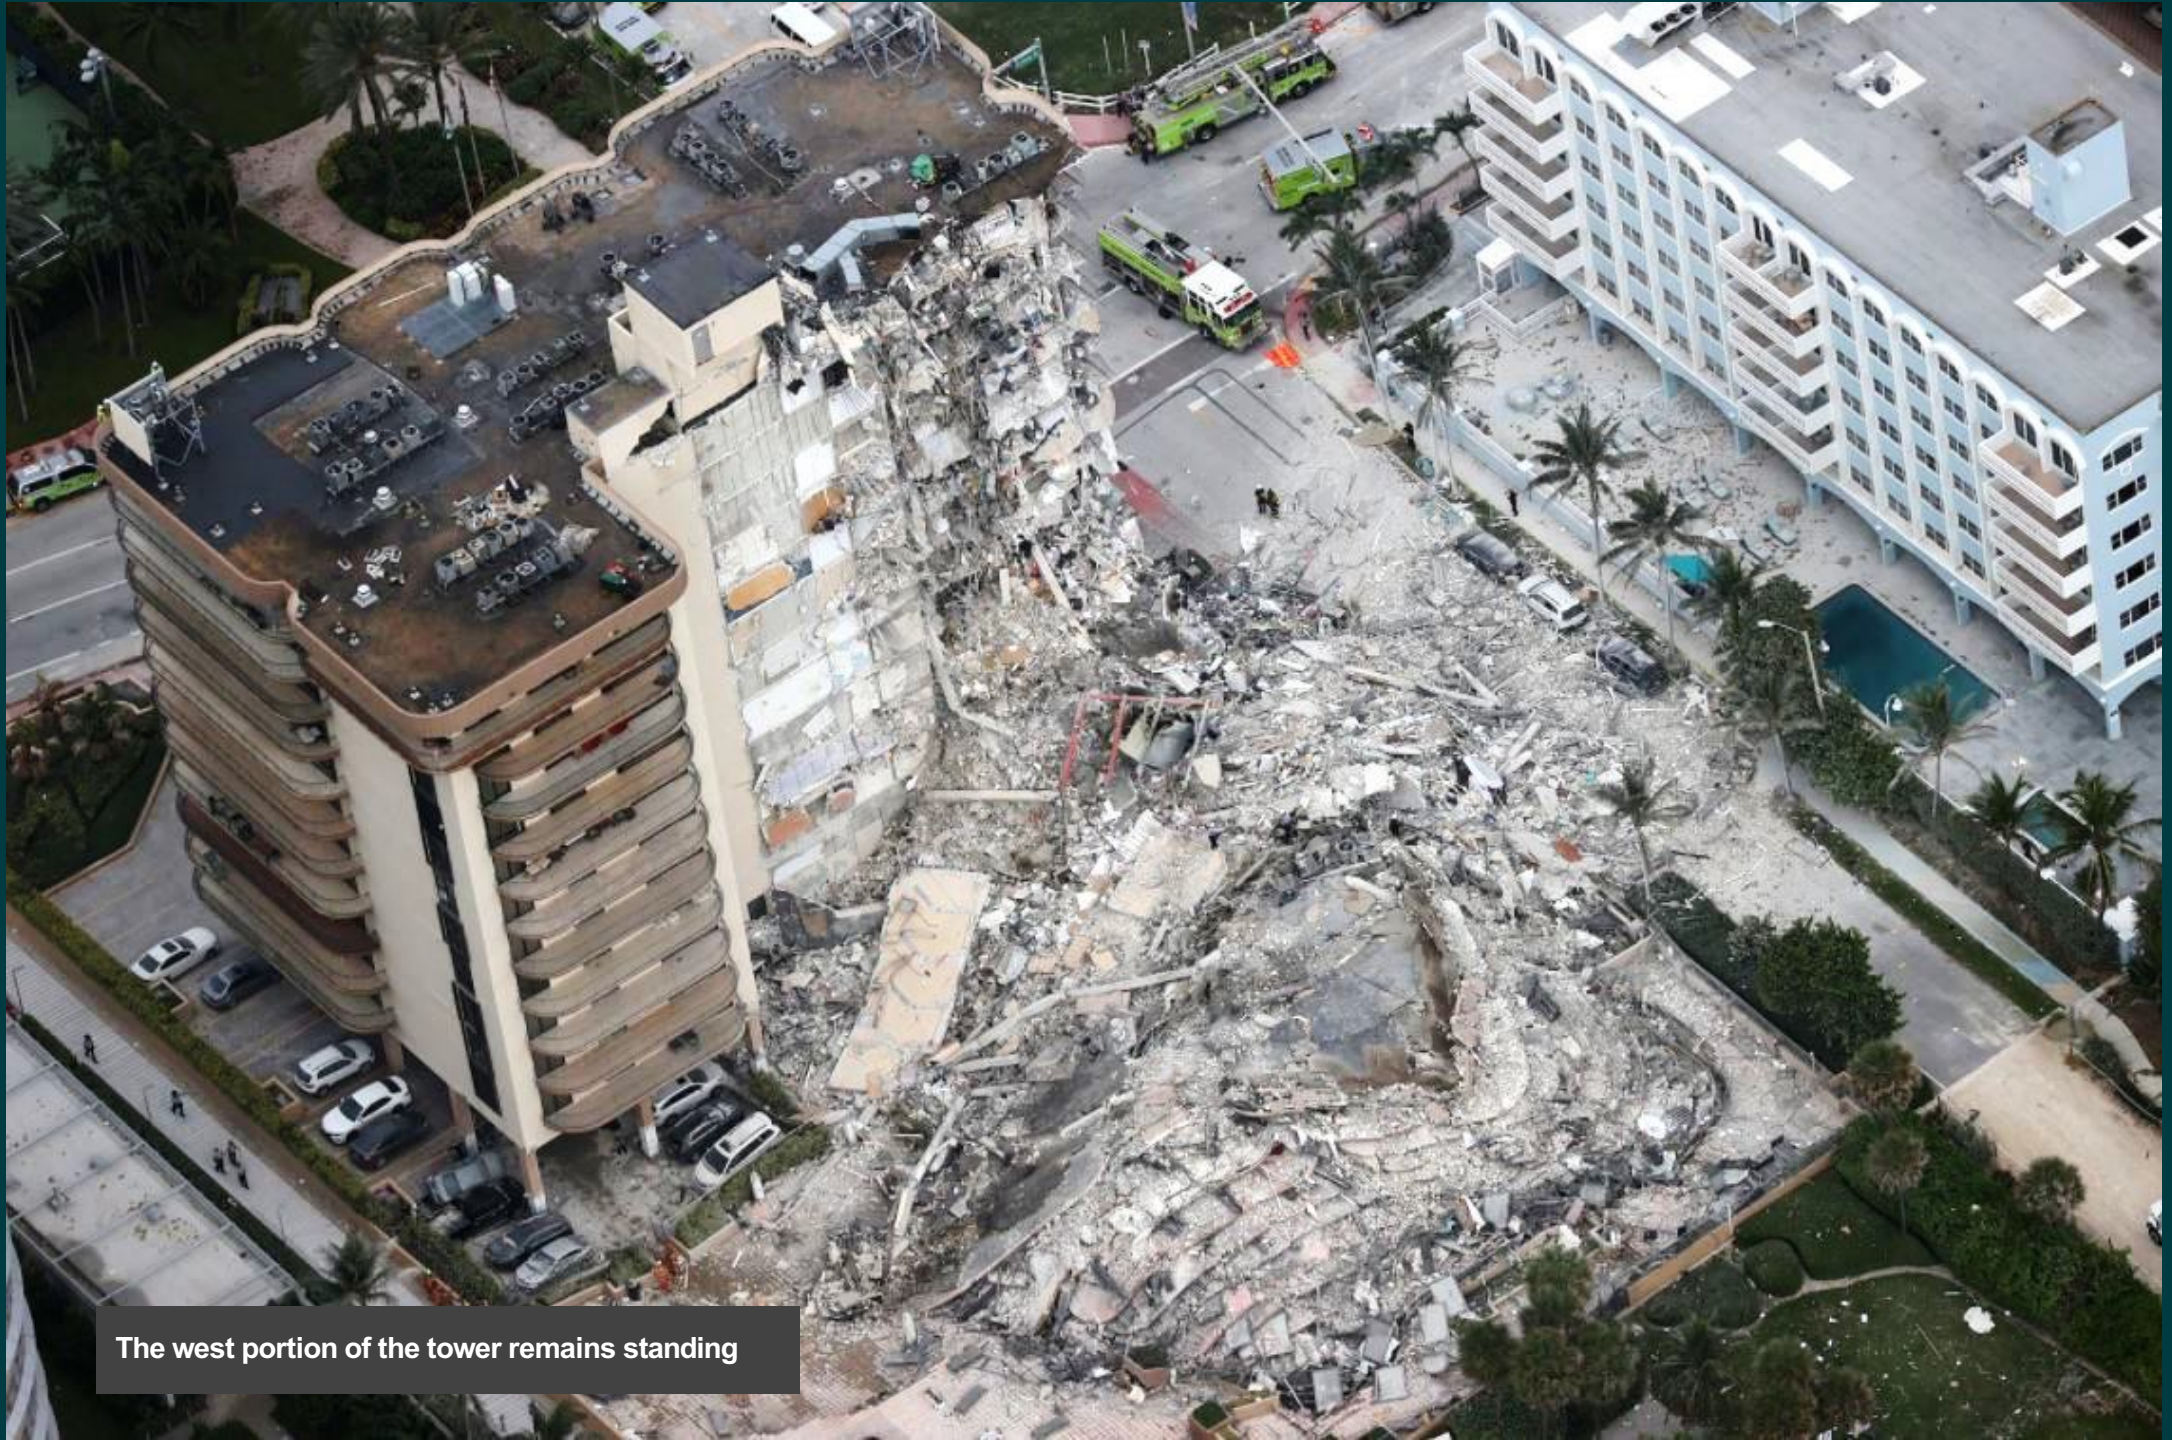
The west portion of the tower remains standing

Final location of northeast stair shear wall. Likely delayed collapse of east portion of tower

Shear wall

Original location of northeast stair shear wall.

The west portion of the tower remains standing likely due to a more robust structure and sizeable shear wall

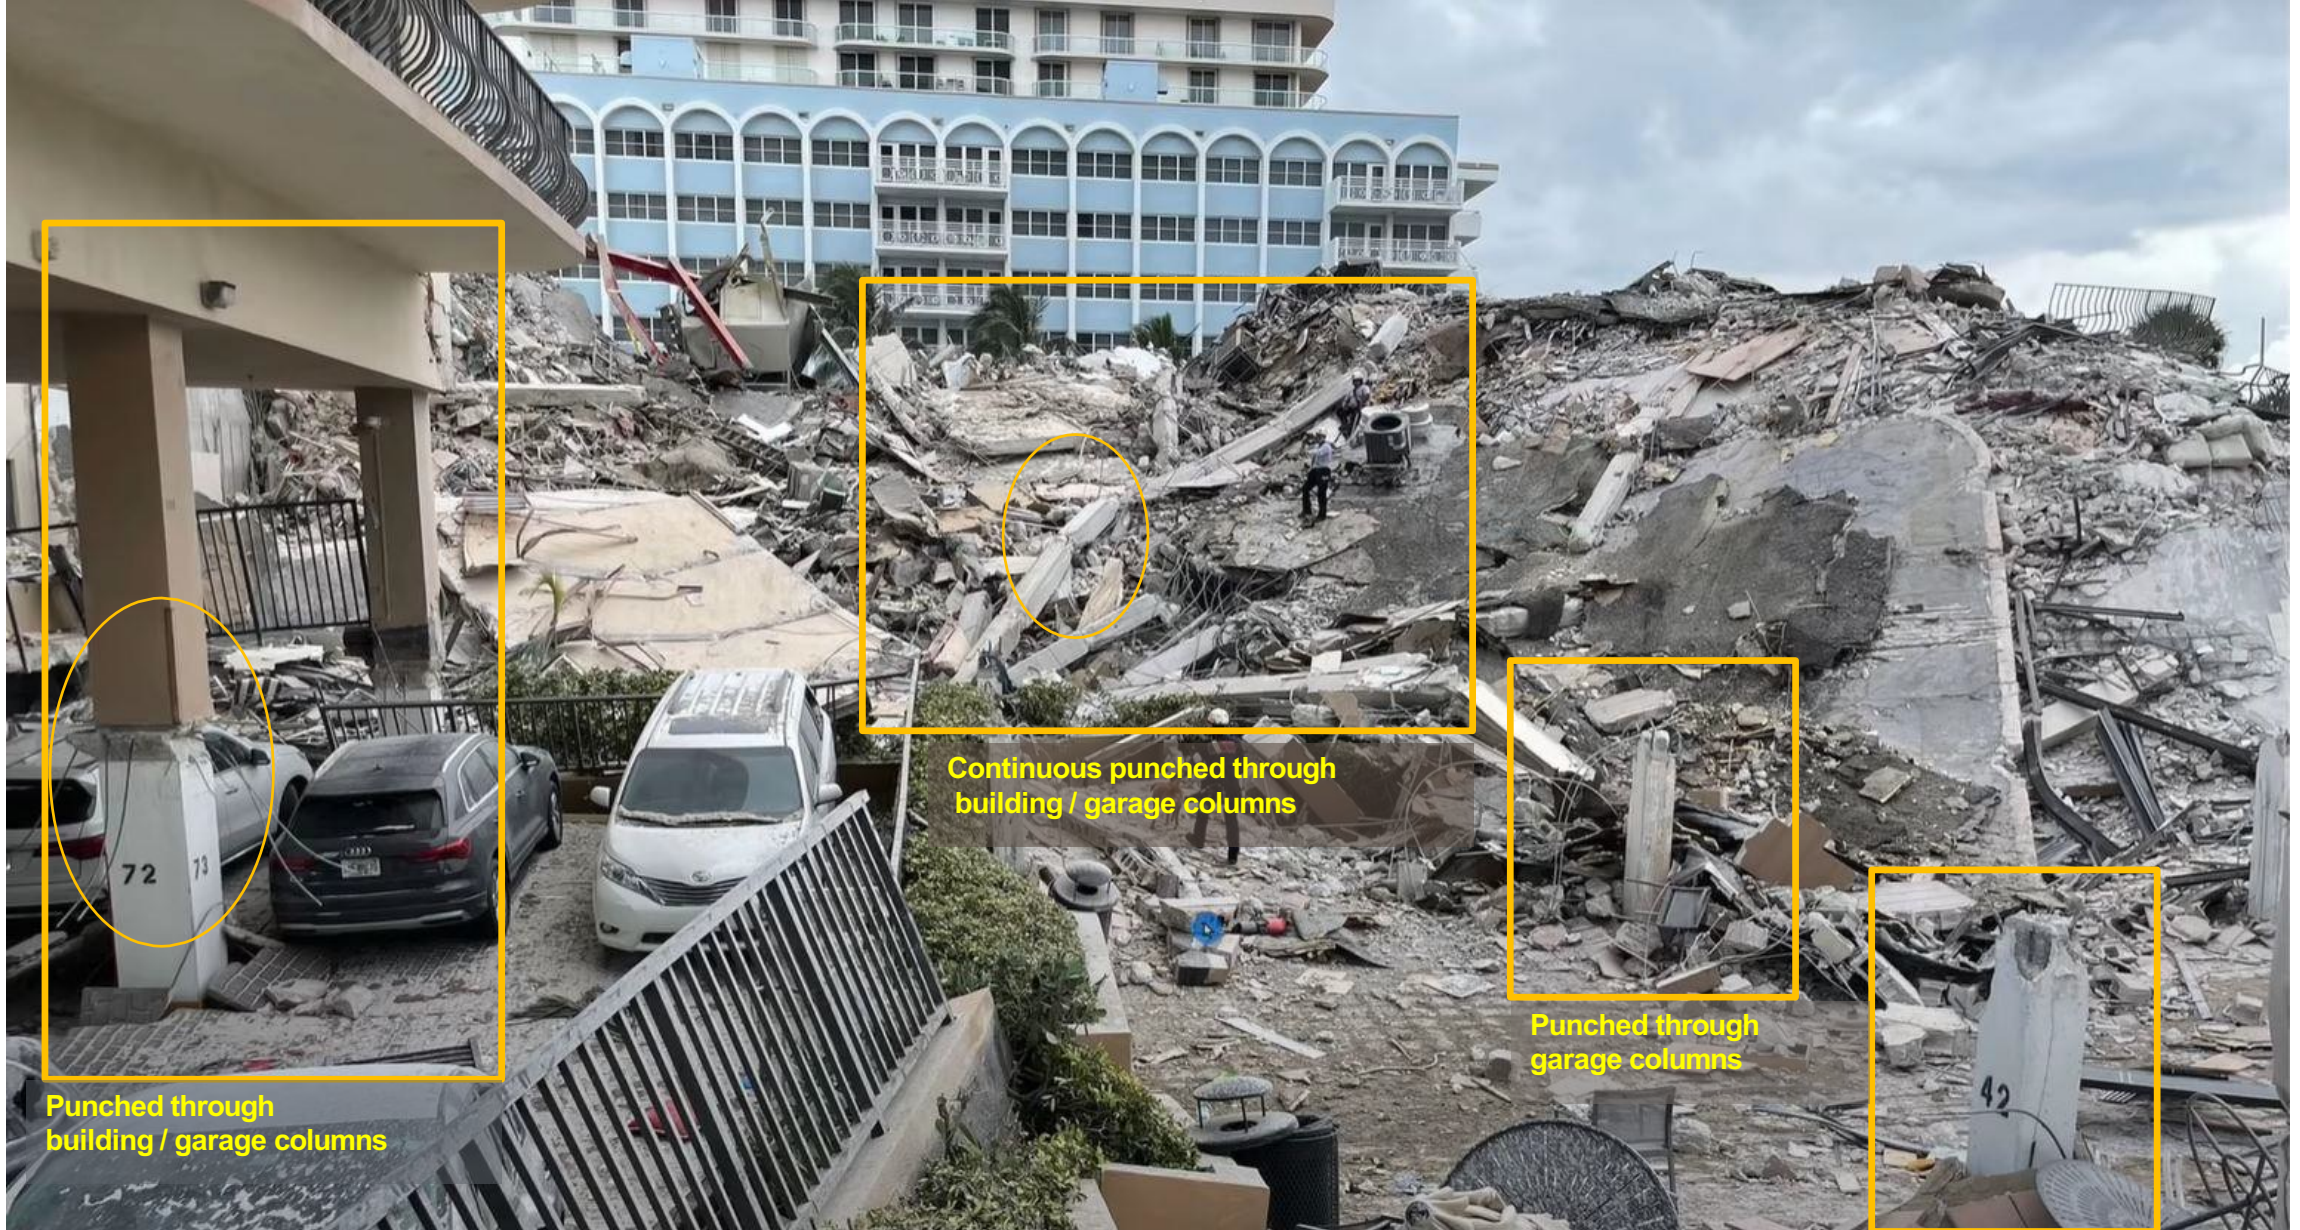
Punched through  
building / garage columns

Continuous punched through  
building / garage columns

Punched through  
garage columns

Parking deck over garage,  
collapsed into garage below

Pool deck over garage, collapsed into garage below

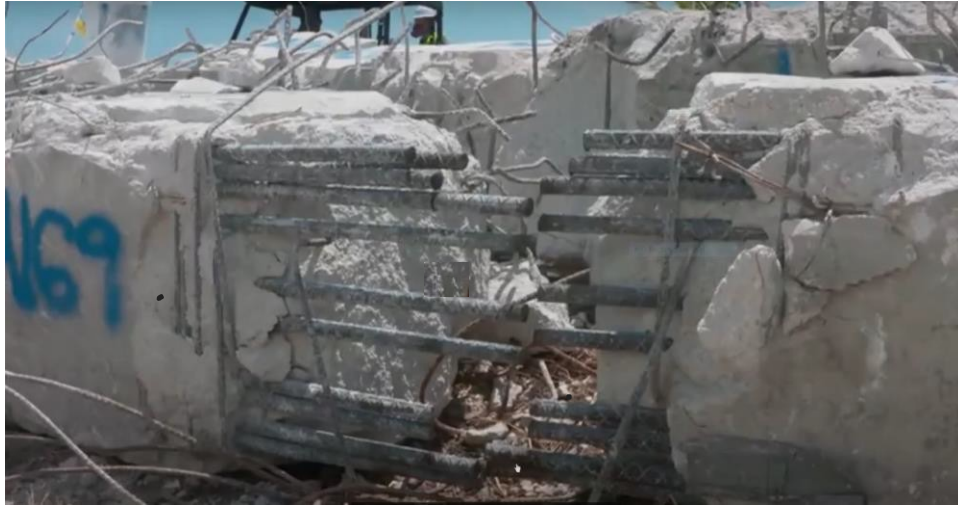
Proximity of reinforcing steel in building and garage columns

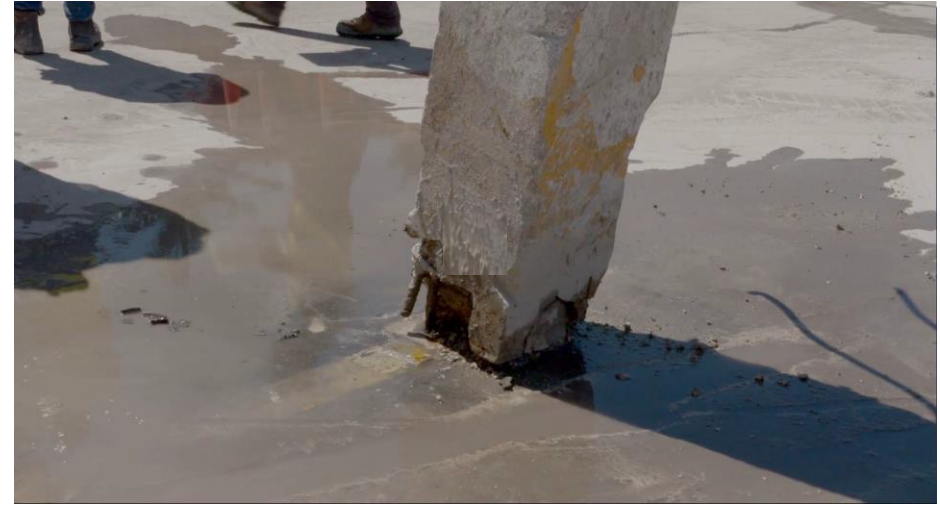
Corrosion of columns at garage slab and foundation

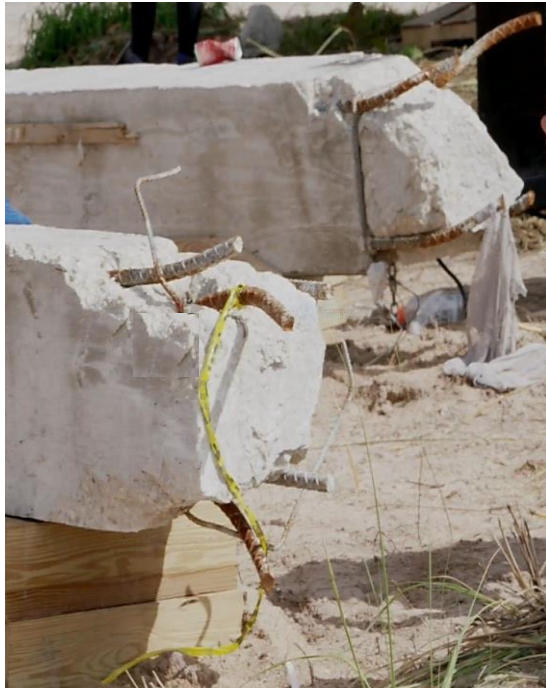
Amount of reinforcing steel in columns

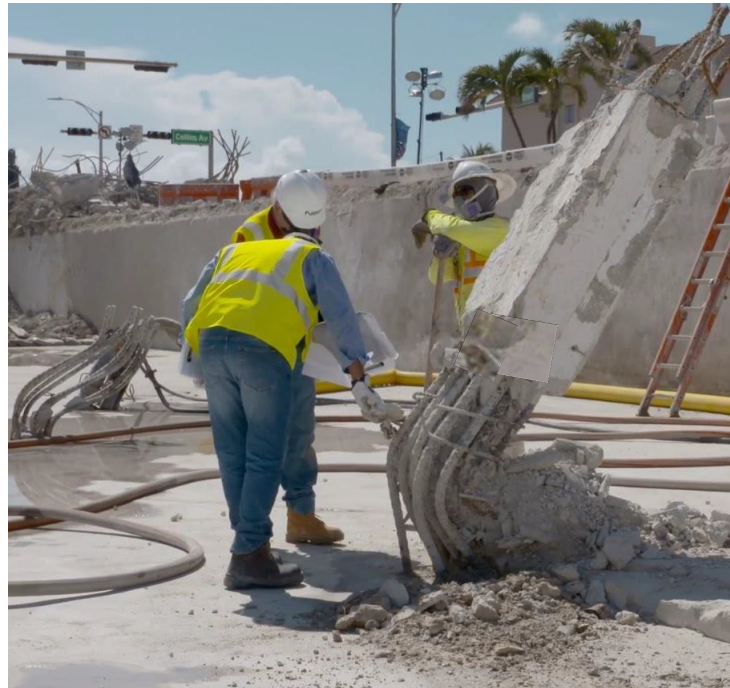
Column to foundation connections

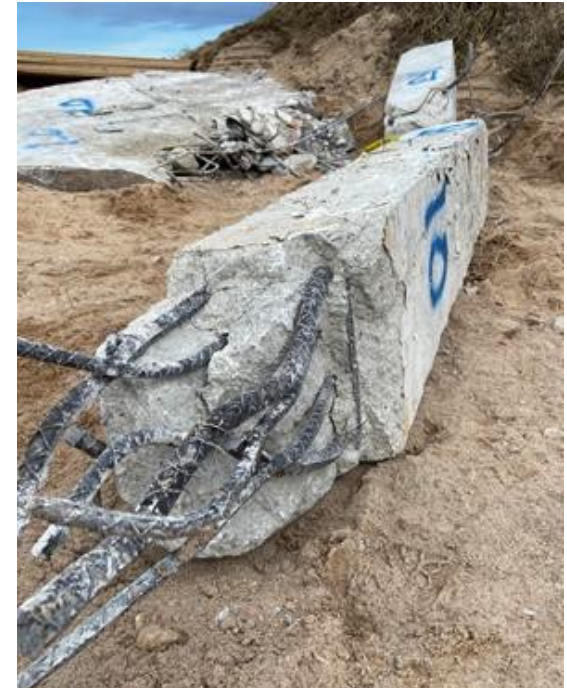
Column to beam connections

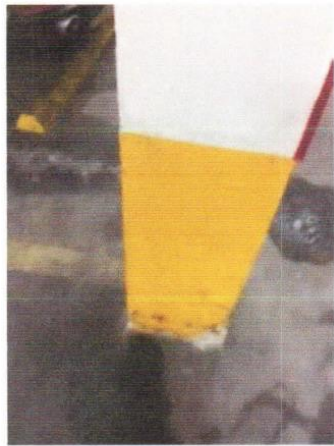
Figure J1: Typical cracking and spalling at parking garage columns

“Abundant cracking and spalling of the columns, beams and walls...sizeable spalls...underside of the pool/entrance drive/planter slabs...instances of exposed deteriorating rebar. Most is minor...concrete deterioration needs to be repaired in a timely fashion.”

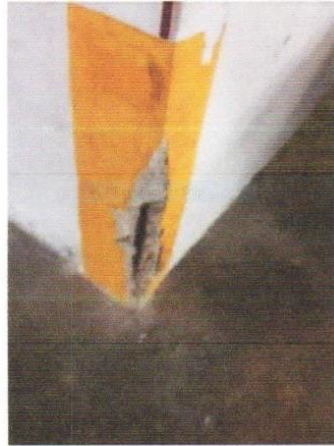
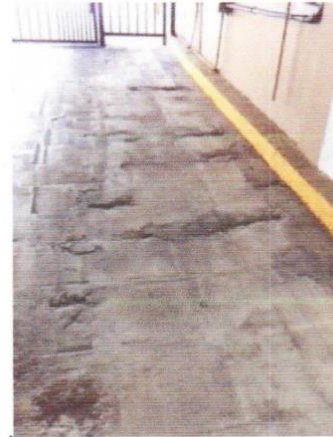
Figure J2: Spalling with exposed steel reinforcement at topside of garage deck.

“The failed waterproofing is causing major structural damage to the structural slab below these areas. Failure to replace the waterproofing in the near future will cause the extent of the concrete deterioration to expand exponentially.”

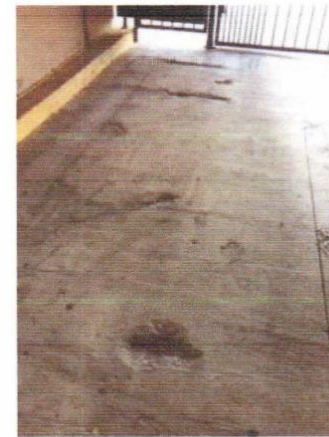
Figure K1: Previously installed failed injection repairs with leaching forming

Figure K2: More previously installed failed injection repairs with leaching forming

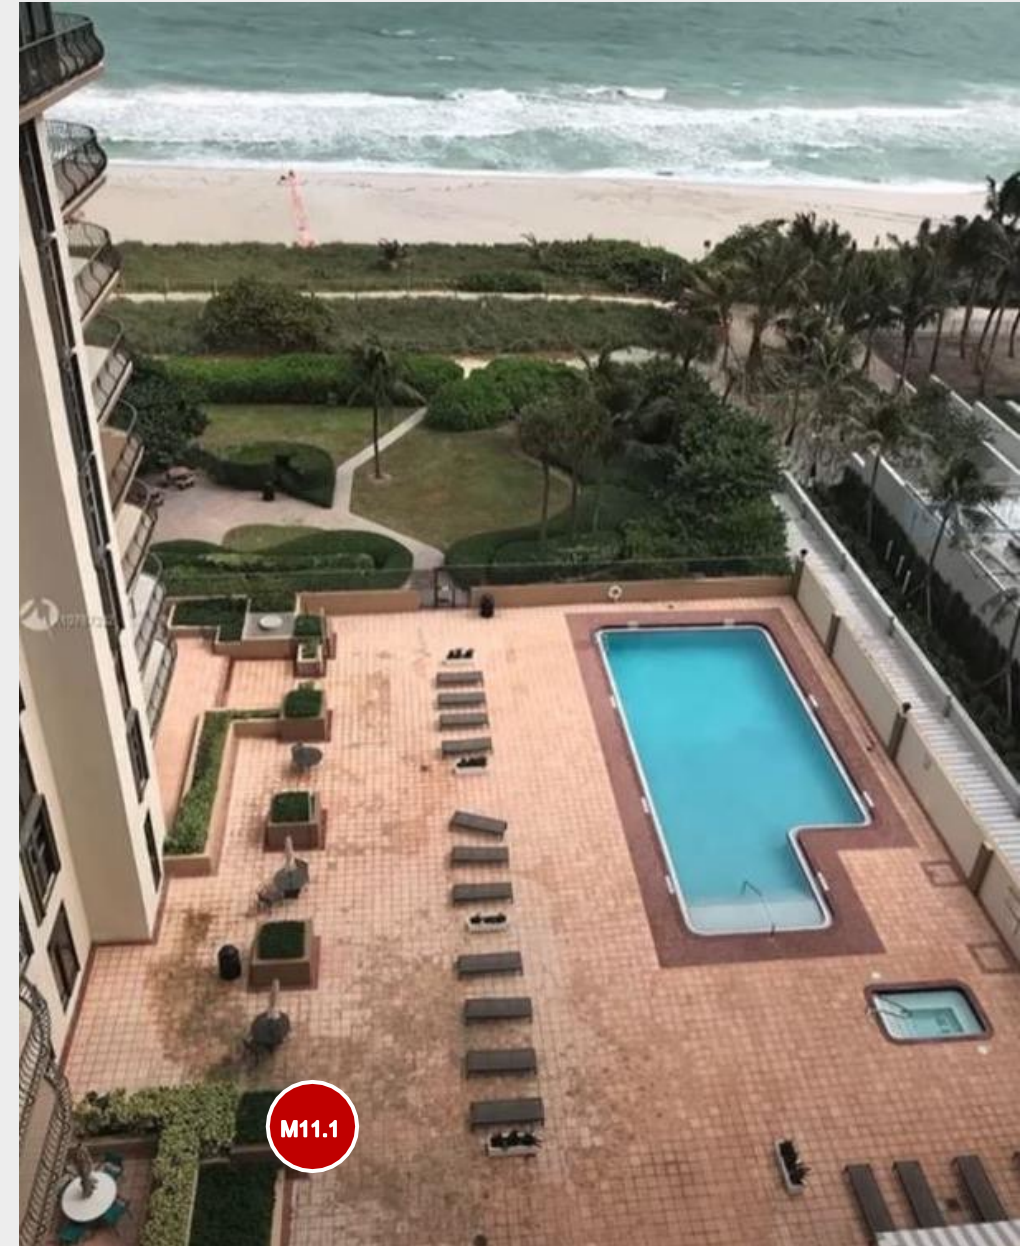
Ponding water at pool deck above garage
